AFWAL-TR-89-2012

IMPROVED FATIGUE LIFE BEARING DEVELOPMENT

June 1989

Final Report for Period September 1984 - December 1988

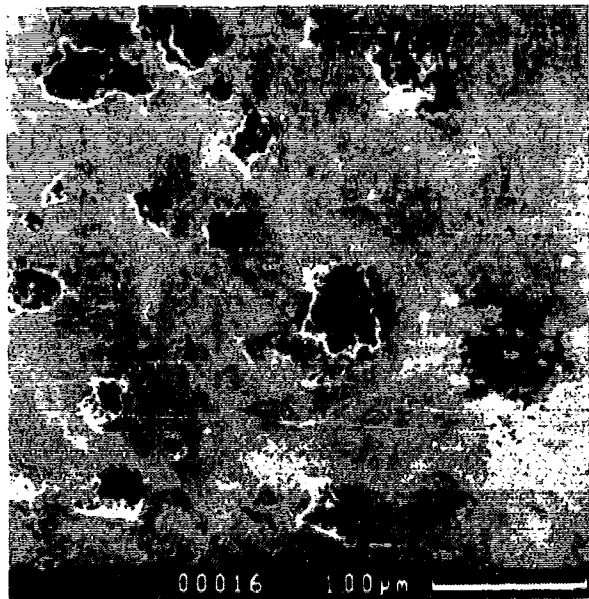
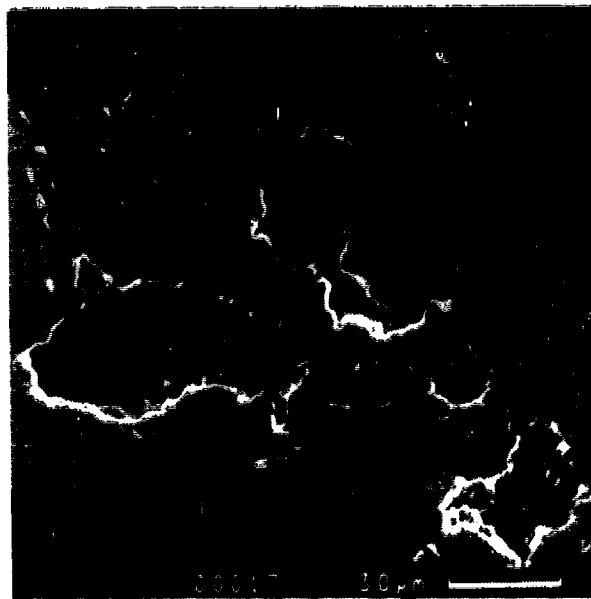
Figure 11 illustrates typical corrosion pits in M50, with the usual "mud-cracking" appearance indicated in the lowest photo. Figure 12 shows incipient surface fatigue spalling that initiated at corrosion pits.

Figure 11. Corrosion Pits in M50 Bearing Steel. Notice typical "mudcracking" appearance.

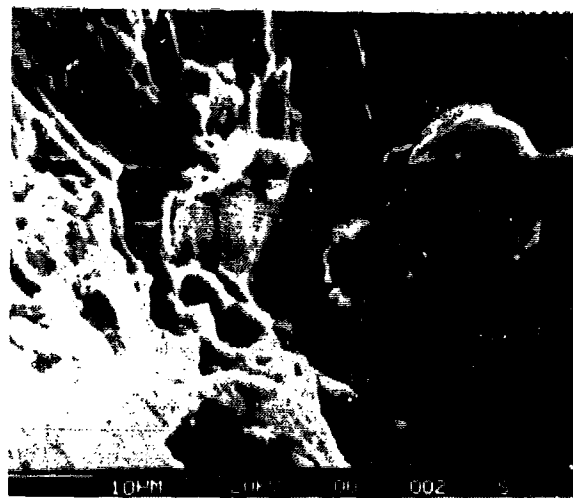
Figure 27. Microspalling Resulting from Debris Denting. *Note burnished layer surrounding spalled area (top photo) indicating deformation caused by dent.*

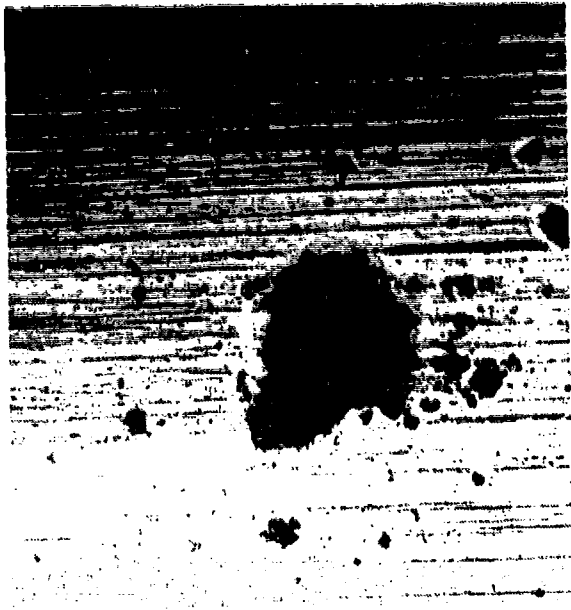
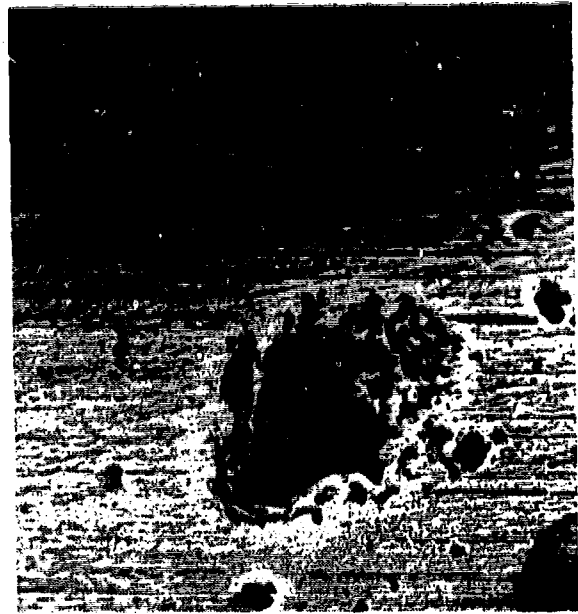
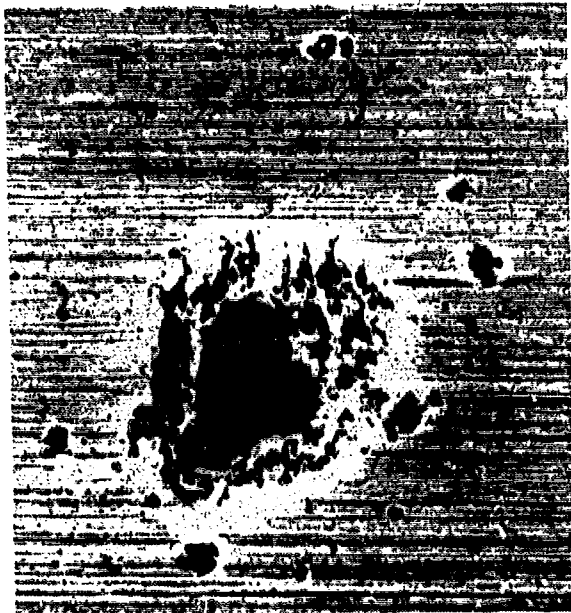
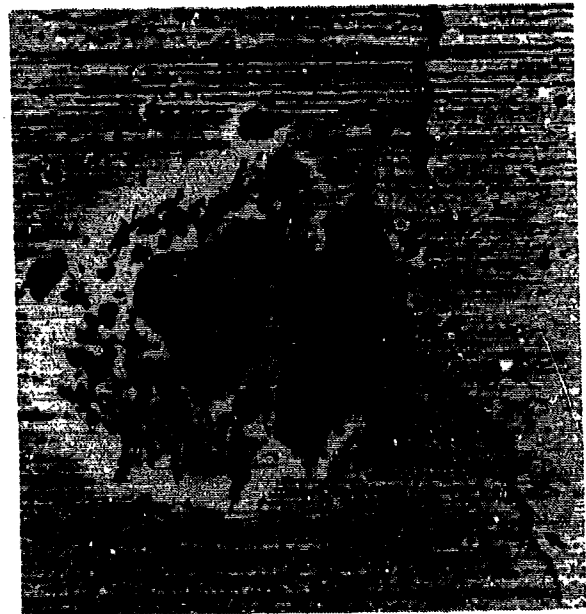
Figure 41. Ring 54 After Contamination Run (100 \times).

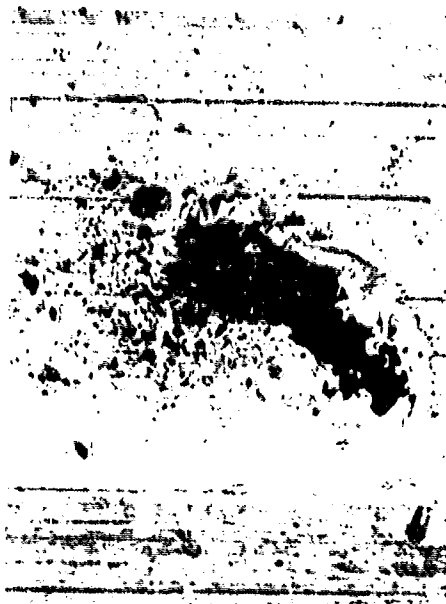
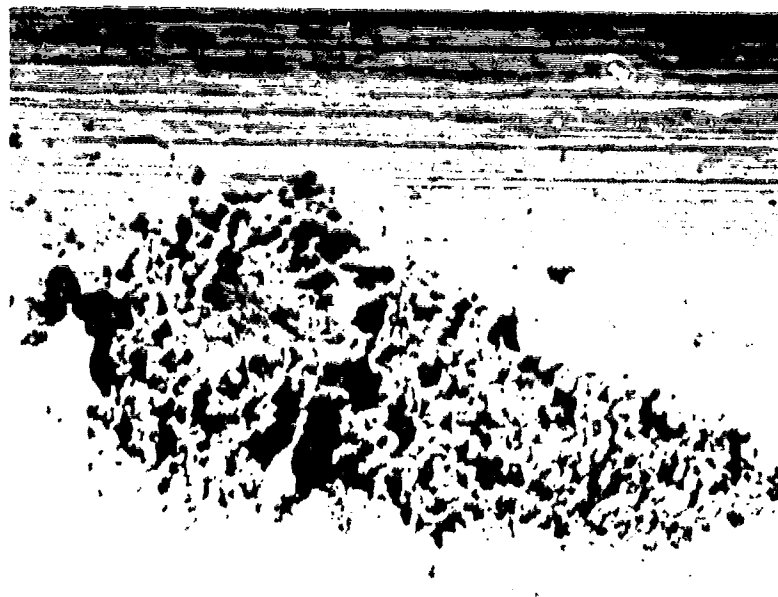
(a) After 275 hours

(b) After 325 hours

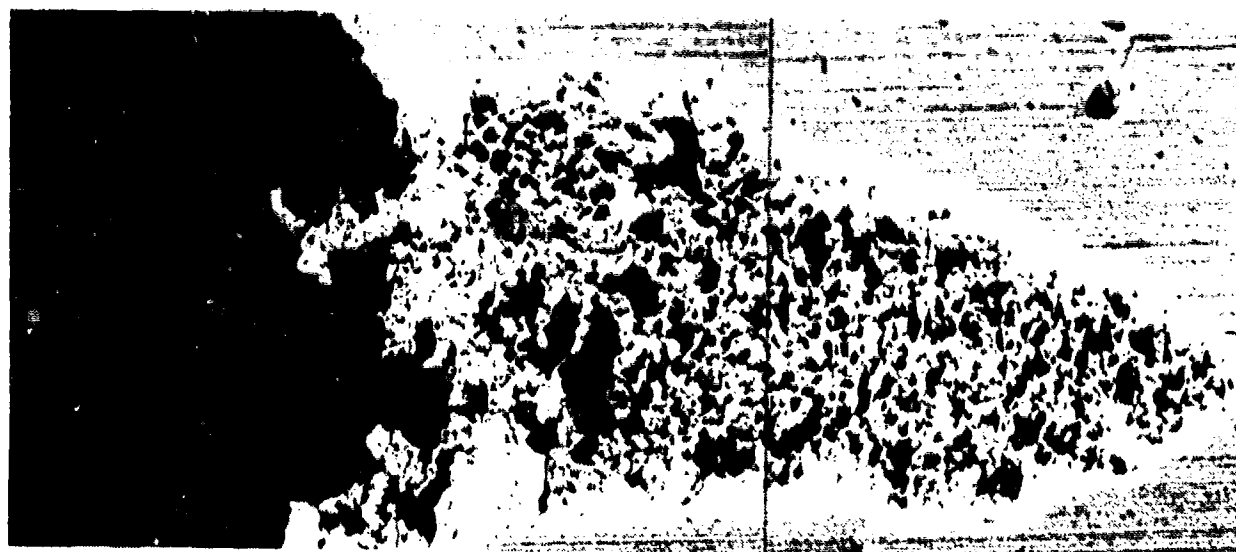
(c) After 346 hours

Figure 41 shows a similar sequence for Ring 54. The initial flaw is shown at top left. The propagation by peeling is shown in the subsequent photomicrographs, with the final spall in the last panel. Figure 42 shows the initial flaw and the final spall in Ring 29. Figures 43, 44, and 45 show the propagation of peeling and the final flaws in Rings 35, 91, and 60. Although these rings were not tested with the exact same procedure as the rings mentioned previously, the mechanisms were similar, and the failures fit well within the Weibull distribution. The failure in Ring 10, Figure 46, is somewhat unusual in that the initial damage formed in the scuffed region surrounding a small dent. The flaw propagated by peeling, and then terminated in a spall.

Figure 43. Ring 35 Nonstandard Run (100 \times). Contaminated balls were added after 25 hours.

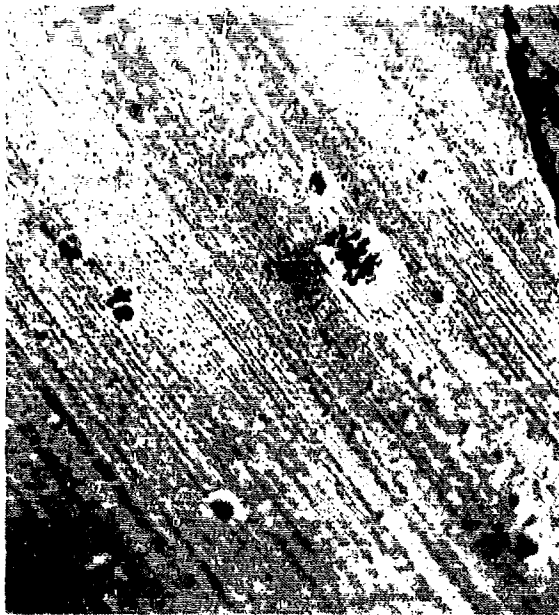
Figure 45. Ring 60 Nonstandard Run. Contaminated balls were added after 300 hours; contaminated retainer was added after 311 hours.

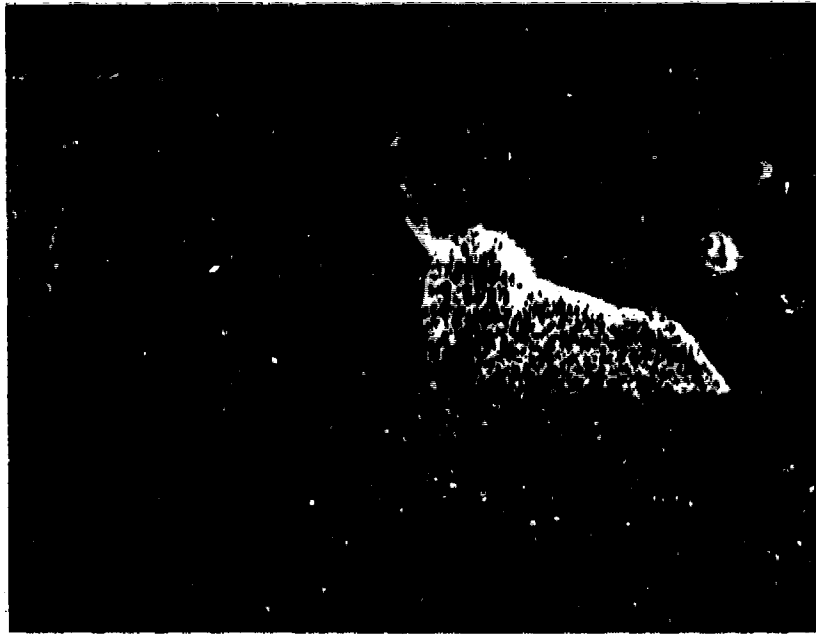
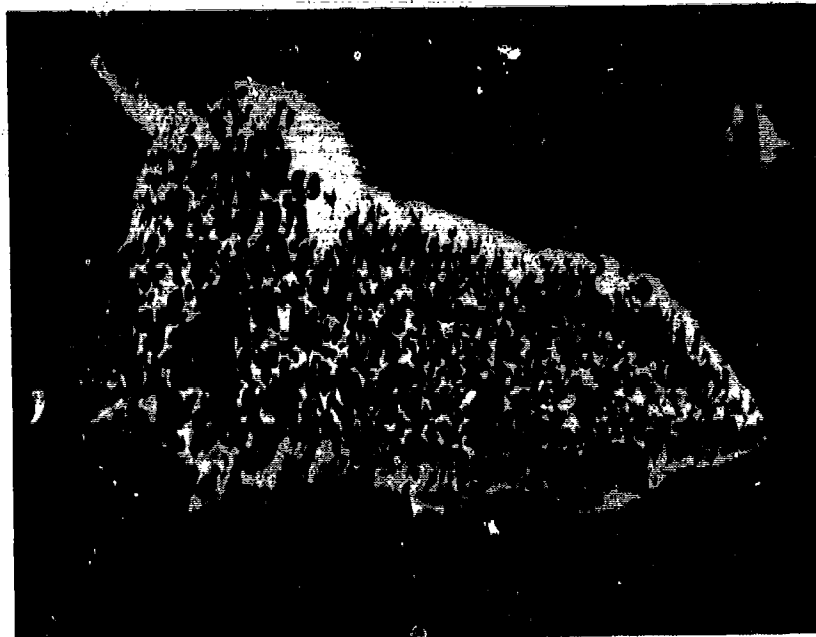
Figure 45. Ring 60 Nonstandard Run (Concluded).

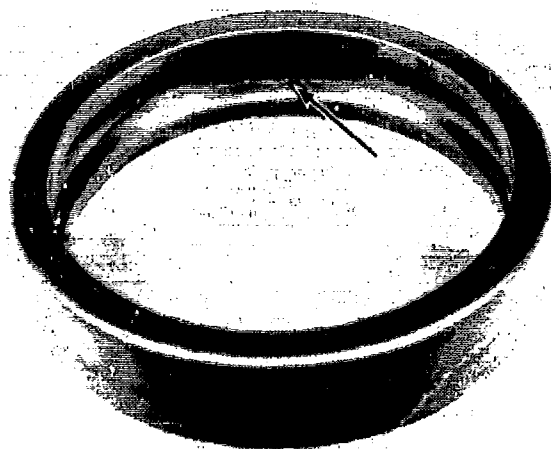
Figure 60. Localized Area of Corrosion Due to Lack of Coating.

Outer Ring (M50NiL) - Running track burnished, slight evidence of ring rotation on outer diameter. Cage rub indications on shoulder. TDC coating intact on all areas except one patch (see Figures 60 and 61). SEM examination of this area indicated a coating problem (peeling) presumed due to a processing anomaly.

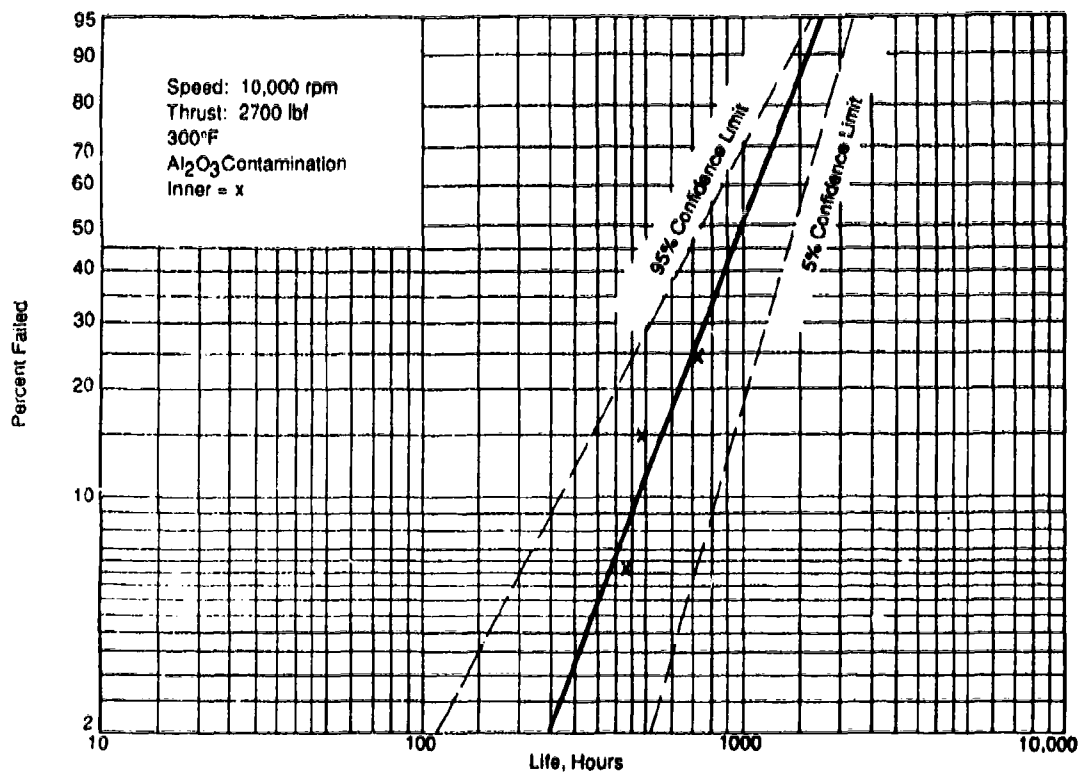
Figure 65. M50NiL TDC Life Test.

Testing of the remaining M50NiL TDC coated bearings with bare M50 balls was resumed after the bearing corrosion test. The results of these tests are tabulated in Table 9 and the Weibull distribution is plotted in Figure 65. A total of 11 tests were performed. As can be seen from Table 9, only three inner-ring failures were experienced compared to the seven inner-ring failures noted in the M50 baseline tests (Table 7). Interestingly, two ball failures were encountered, indicative of the possibility that with M50NiL rings the rolling elements (ball or rollers) become a likely failure component. The three failures calculate a B_{10} life of 480 hours which is 5.5 times that for the M50 baseline bearings. The 480-hour B_{10} life is 20 times the calculated AFBMA life for this bearing. A comparison of these data is shown in Figure 66. Based on these results, coupled with the corrosion test results, it can be seen that the program goals (3 to 5 \times life improvement with improved corrosion resistance) were met quite successfully.

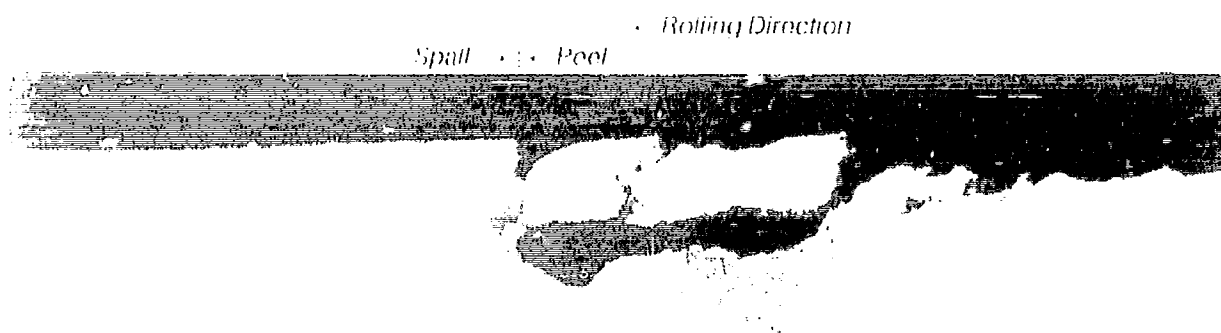
Peeling and the subsequent spalling crack may be seen more clearly from the circumferential section shown in Figures 71 and 72. The depth of the peel is about 0.004 inch. This can be seen in Figure 71 from a section of the peel which is almost completely undermined but still in place. The peeling apparently proceeded by means of a sequence of small crack parallel to the surface at about this depth. A spalling crack formed at the end of the peel; typically, these cracks started at an angle of about 20° to the surface plane. The crack direction changed as it propagated to form the classic spalled flare. In Figure 72, a longitudinal section through the peeled region in Ring 35 shows the typical shallow scalloping mechanism of this mode of failure. The propagation of the peeling by the development of shallow subsurface cracks parallel to the surface is also evident (Figure 73).

Figure 71. Longitudinal Section Through Peeled Region in M50 Ring 20 (400 \times).

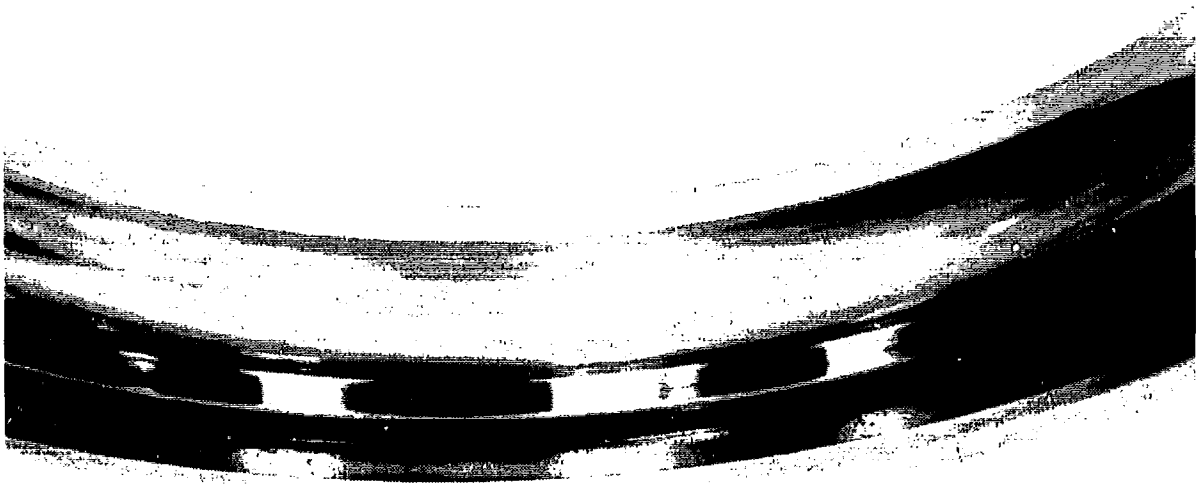
The bearing selected was a 133-mm bore mainshaft ball bearing common to the GEAE F101, F110, CFM56 family of engines. Two of these bearings were manufactured. The inner and outer rings were M50NiL, TDC coated; the balls were M50, and the cage was silver-plated 4340. To evaluate the bearing, it was run as a "slave bearing" on a two-bearing shaft component test. Initially it had only been the intention to run a continuous steady-state (constant load and speed) test for 150 hours. However, because the M50NiL bearing was "piggy backed" onto a special test cycle, the bearing actually saw a much more intensive duty cycle than had been planned. The actual test schedule is shown in Table 14. After 229.7 hours of testing, the bearing was disassembled and visually examined. As seen in Figures 74 and 75 no evidence of any distress was noted. Particularly encouraging was the fact that, similar to the 208 size bearings, no indication of coating damage was observed in the raceway, despite the fact that the bearing had experienced many shutdown and start-up cycles during the testing.

Figure 74. Outer Raceway of 133-mm Bore Ball Bearing (TDC Coated) After Component Test.

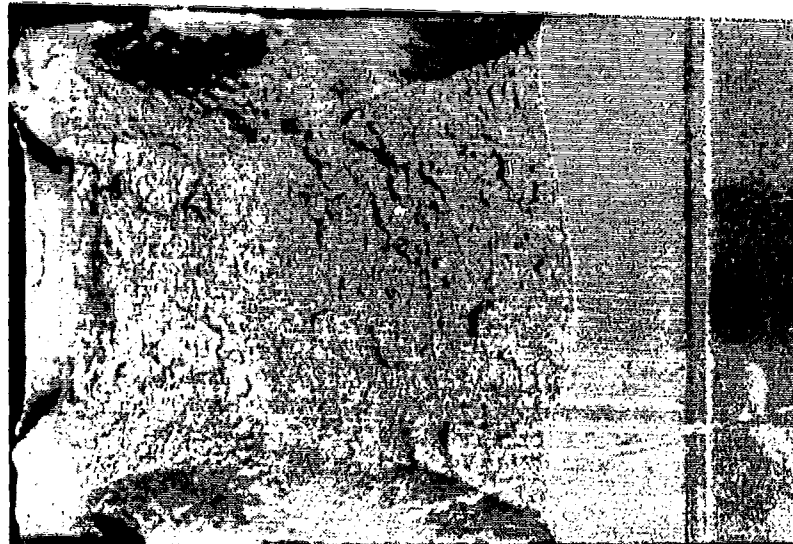
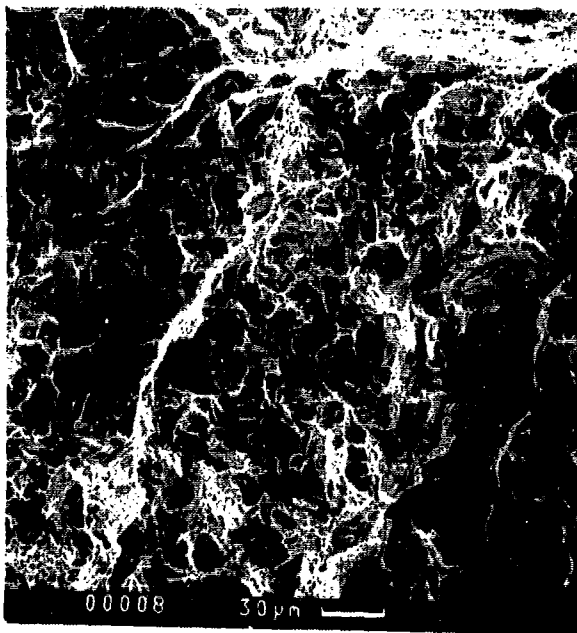
Figure A-3. AISI 9310 Fracture Face (J_{Ic}), -65°F Test.

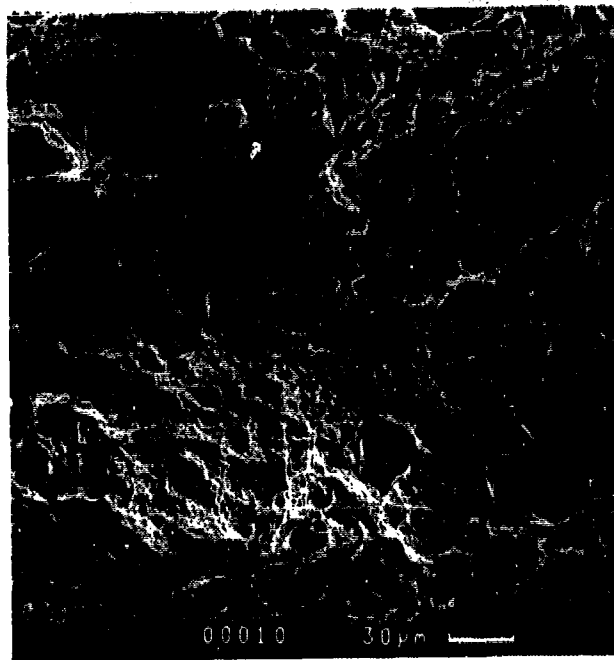
Figure A-4. AISI 9310 Fracture Face (J_{IC}), Room Temperature Test.

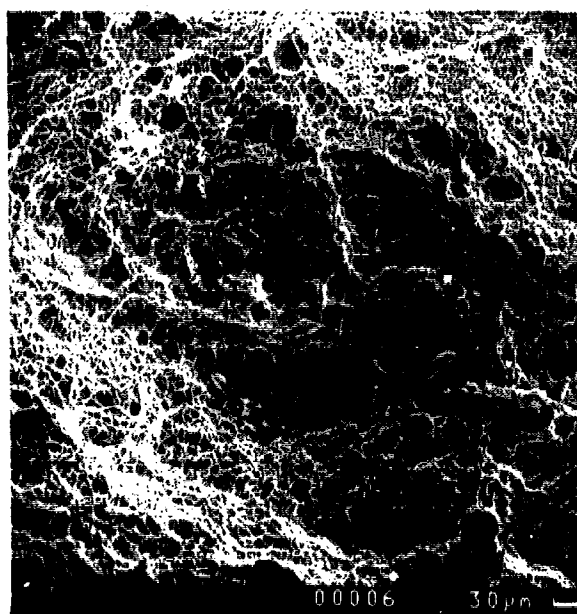
Figure A-5. AISI 9310 Fracture Face (J_{IC}), 250°F Test.

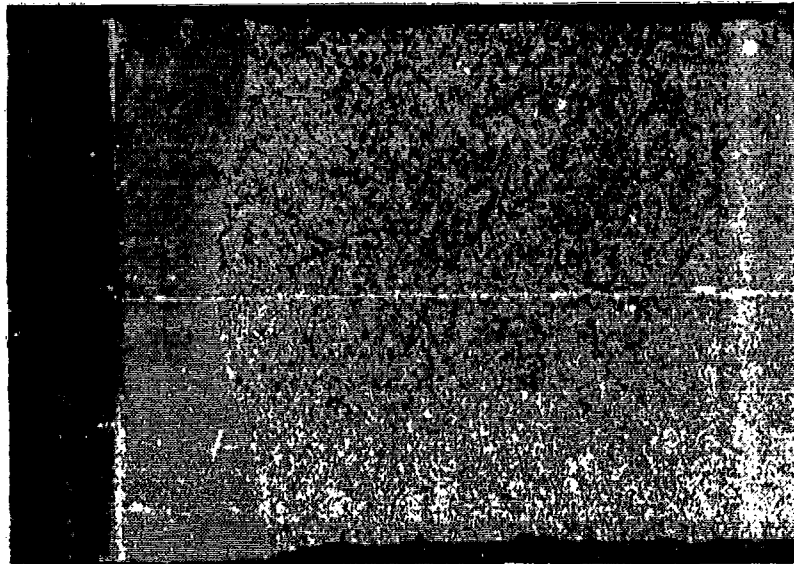
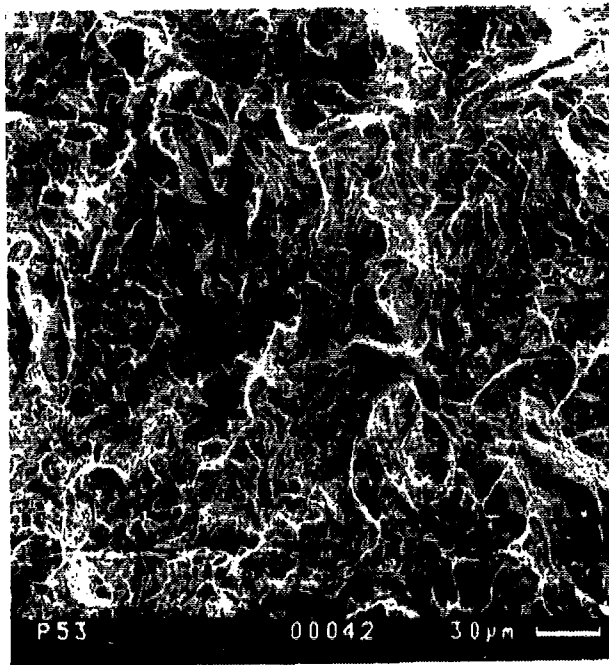
Figure A-6. Pyrowear 53 Fracture Face (K_{Ic}), -65°F Test.

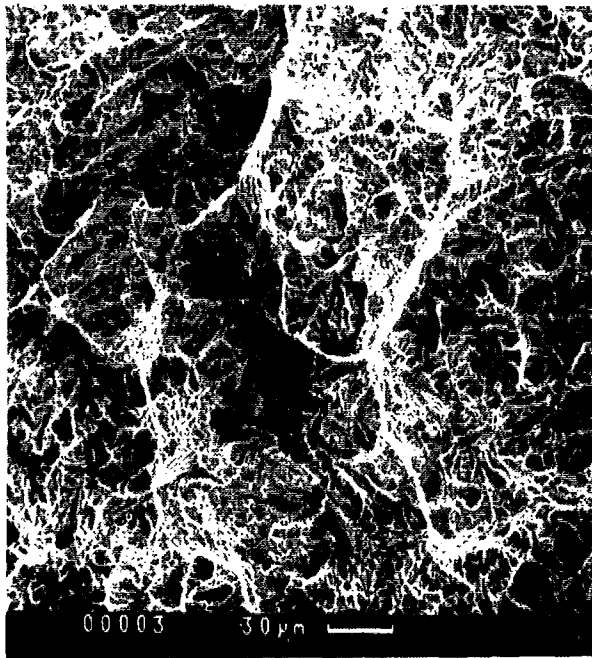
Figure A-7. Pyrowear 53 Fracture Face (K_{Ic}), Room Temperature Test.

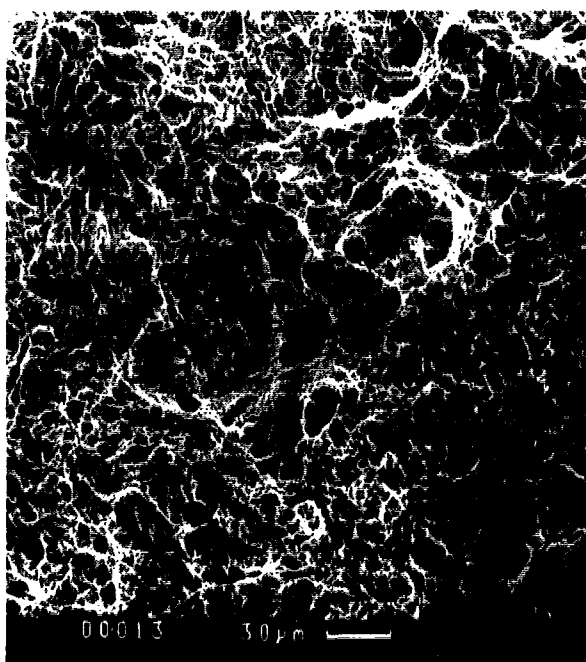
Figure A-8. Pyrowear 53 Fracture Face (J_{IC}), 400°F Test.

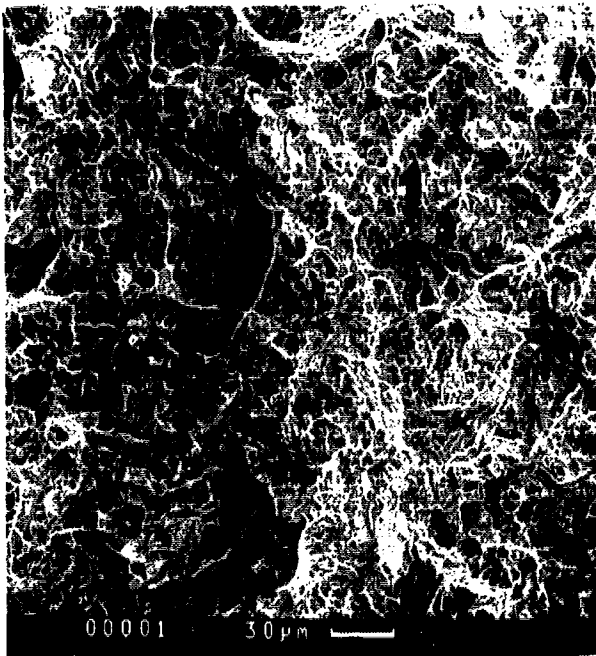
Figure A-9. Pyrowear 53 Fracture Face (K_{Ic}), Aged 1000 Hours at 450°F, Room Temperature Test.
